Re: Geotechnical Interpretive Report – Thurgoona Development located 39 Ceres Drive and 20, 28, 32, 40 & 43 Platinum Court Thurgoona NSW 2640

Re: Geotechnical Data Report – Thurgoona Development located 39 Ceres Drive and 20, 28, 32, 40 & 43 Platinum Court Thurgoona NSW 2640

Attachment A : *Site location and development plan*

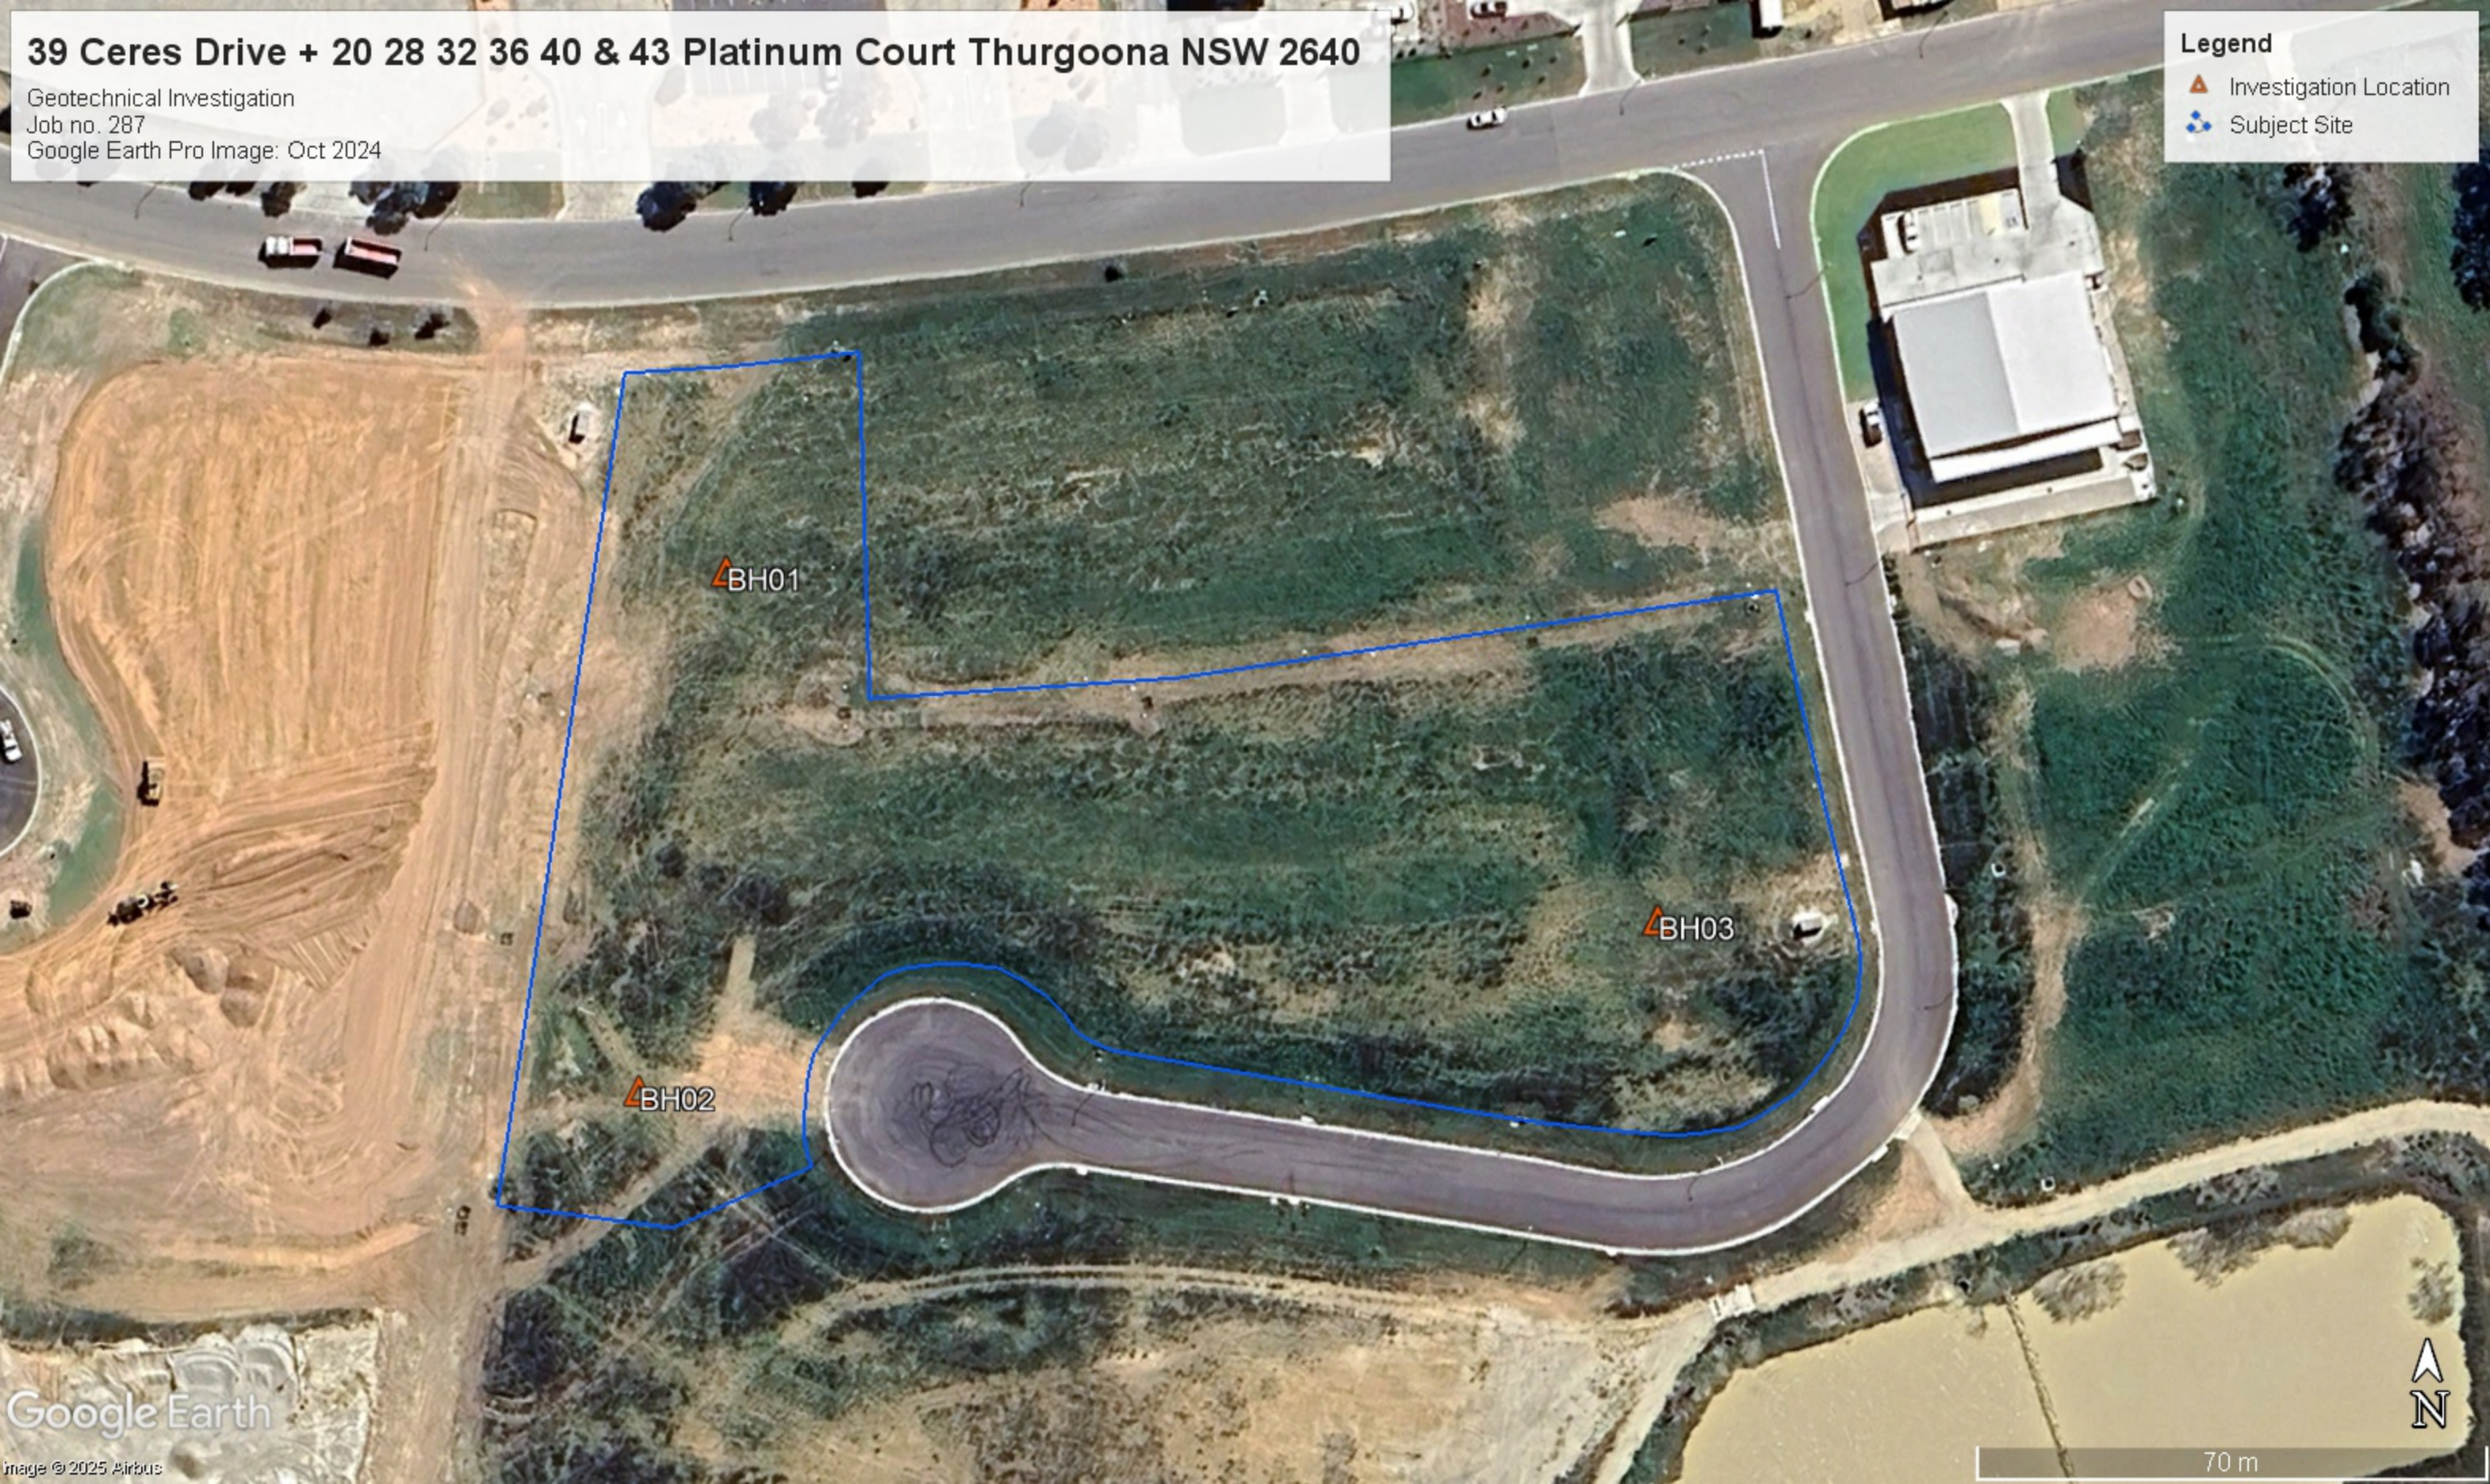
Attachment C : *Plan of the investigation locations*

Geotechnical Investigation
Job no. 287
Google Earth Pro Image: Oct 2024

- Investigation Location
- Subject Site

A plan of the investigation locations can be seen in **Attachment C**.

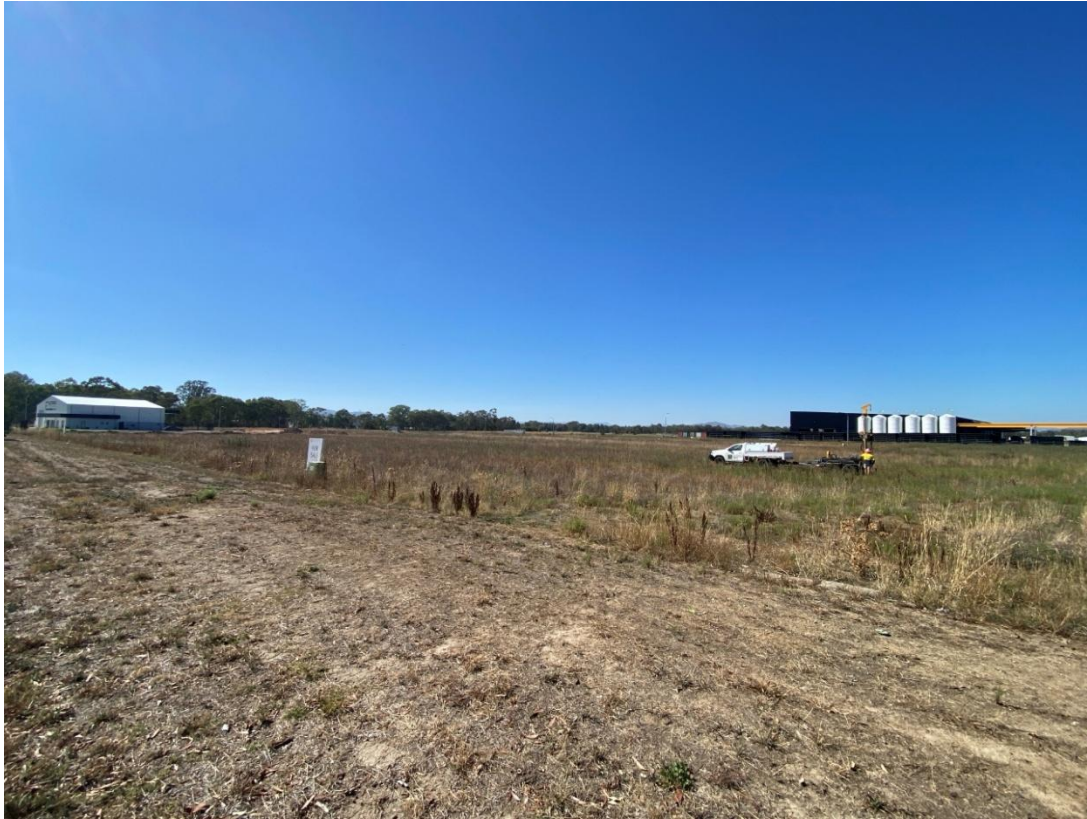
Photograph 1: Site photograph taken facing southeast from Ceres Drive depicting location of BH01.

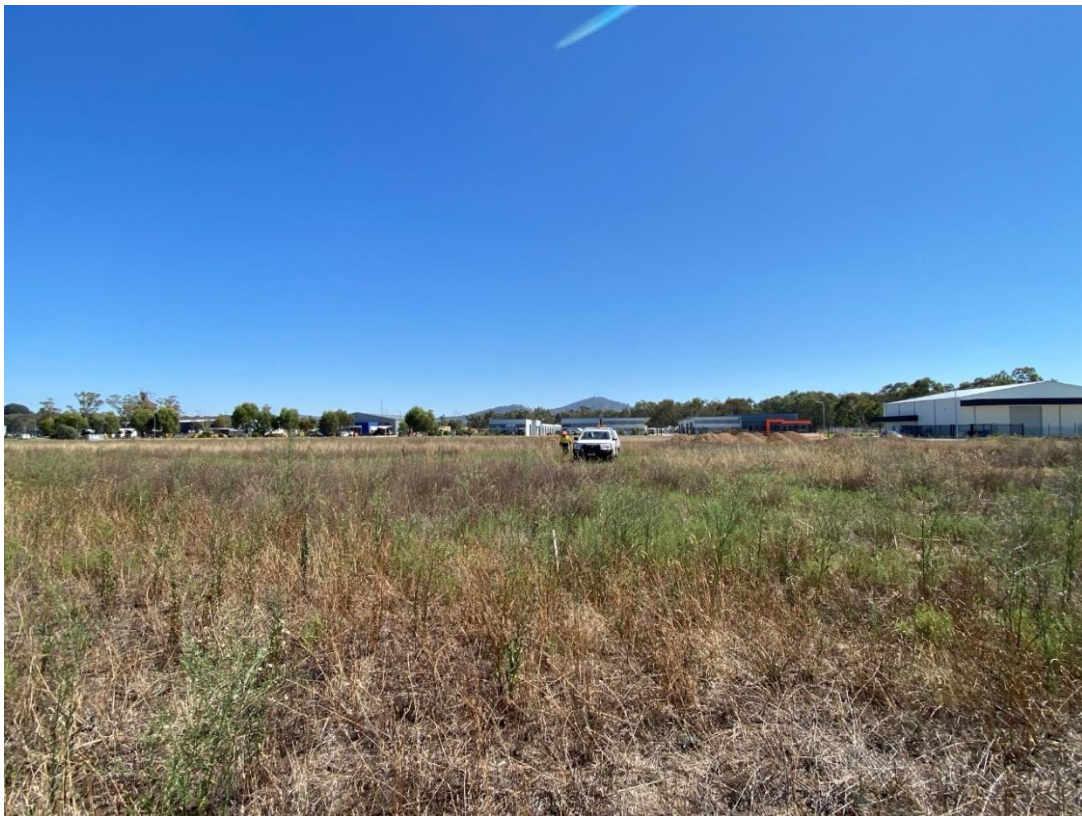
Photograph 2: Site photograph taken facing north from Platinum Court depicting location of BH03.

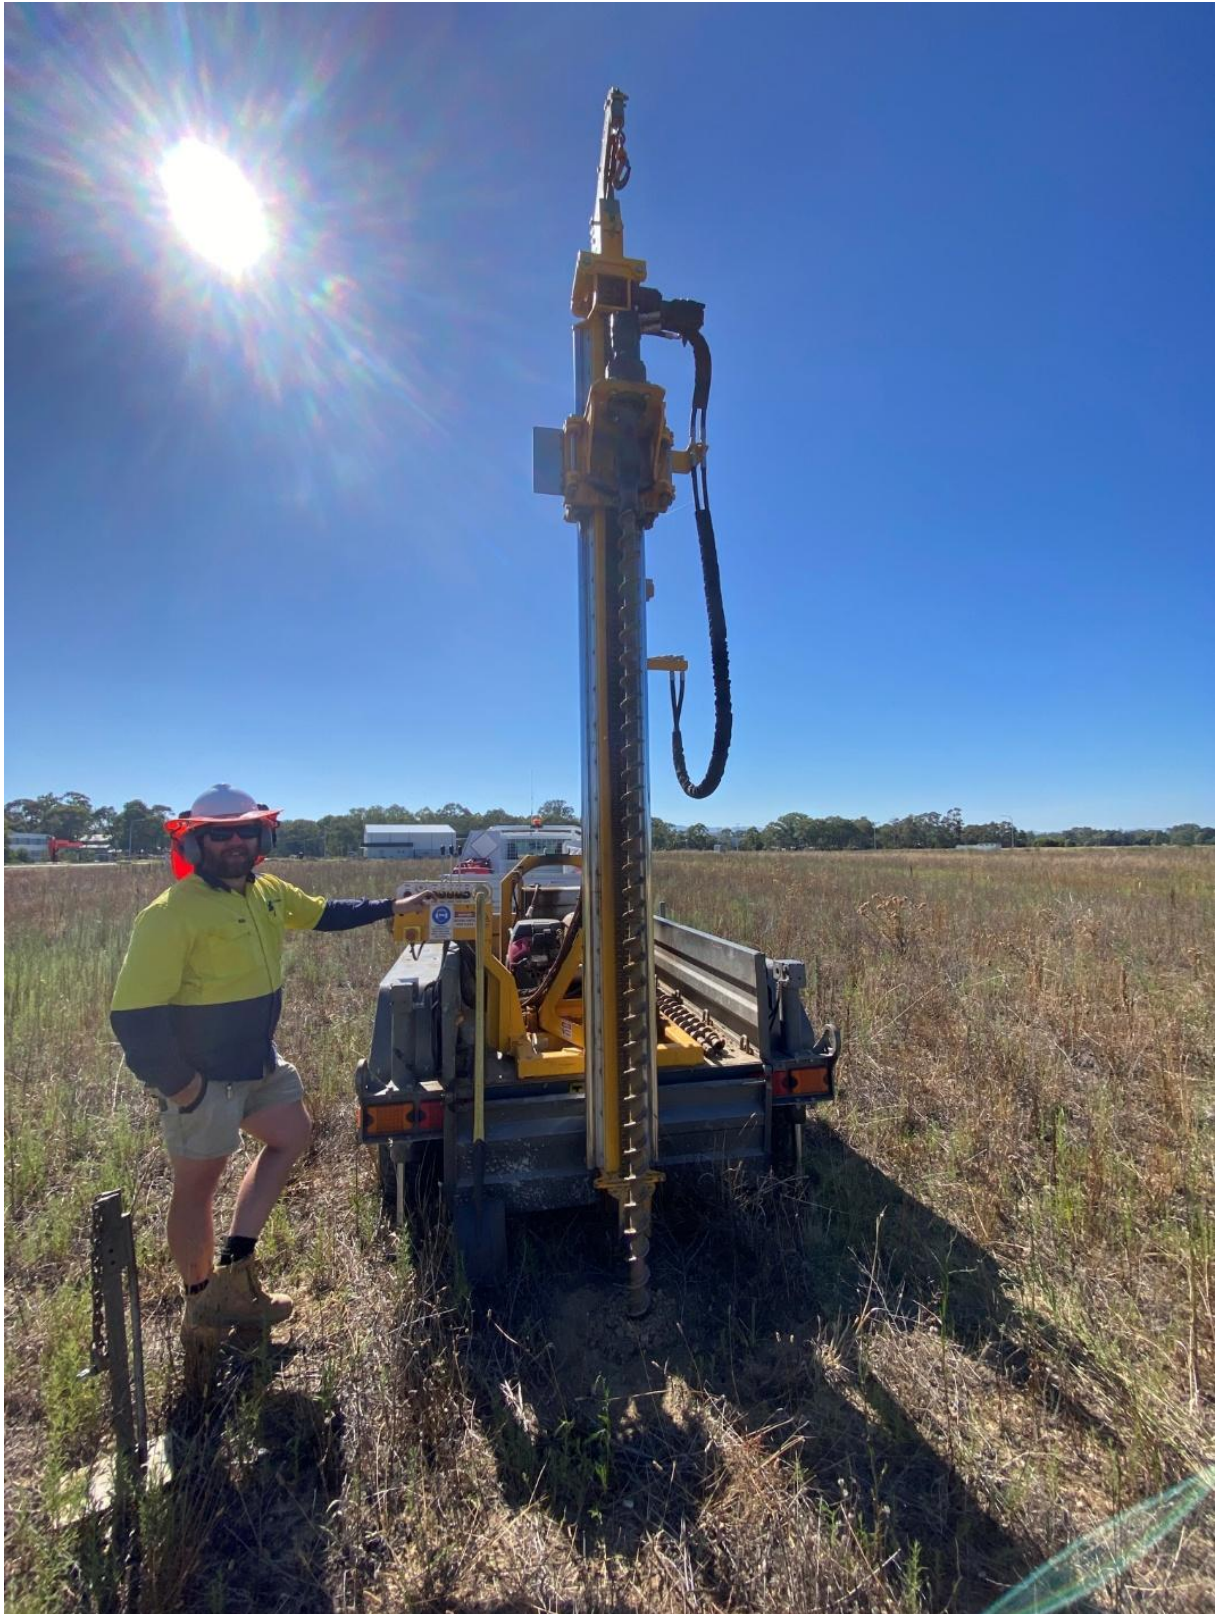
Photograph 3: The sampling method used on site – Power auger.

Three bore holes were drilled using a power auger across the subject site. Disturbed grab soil samples were taken at nominal depths of 1, 2, 3, 4 & 5m depth below ground level. Samples were obtained in accordance with sampling method AS1289.1.2.1 (1998) Methods of testing soils for engineering purposes, sampling and preparation of soils, disturbed samples, standard method.

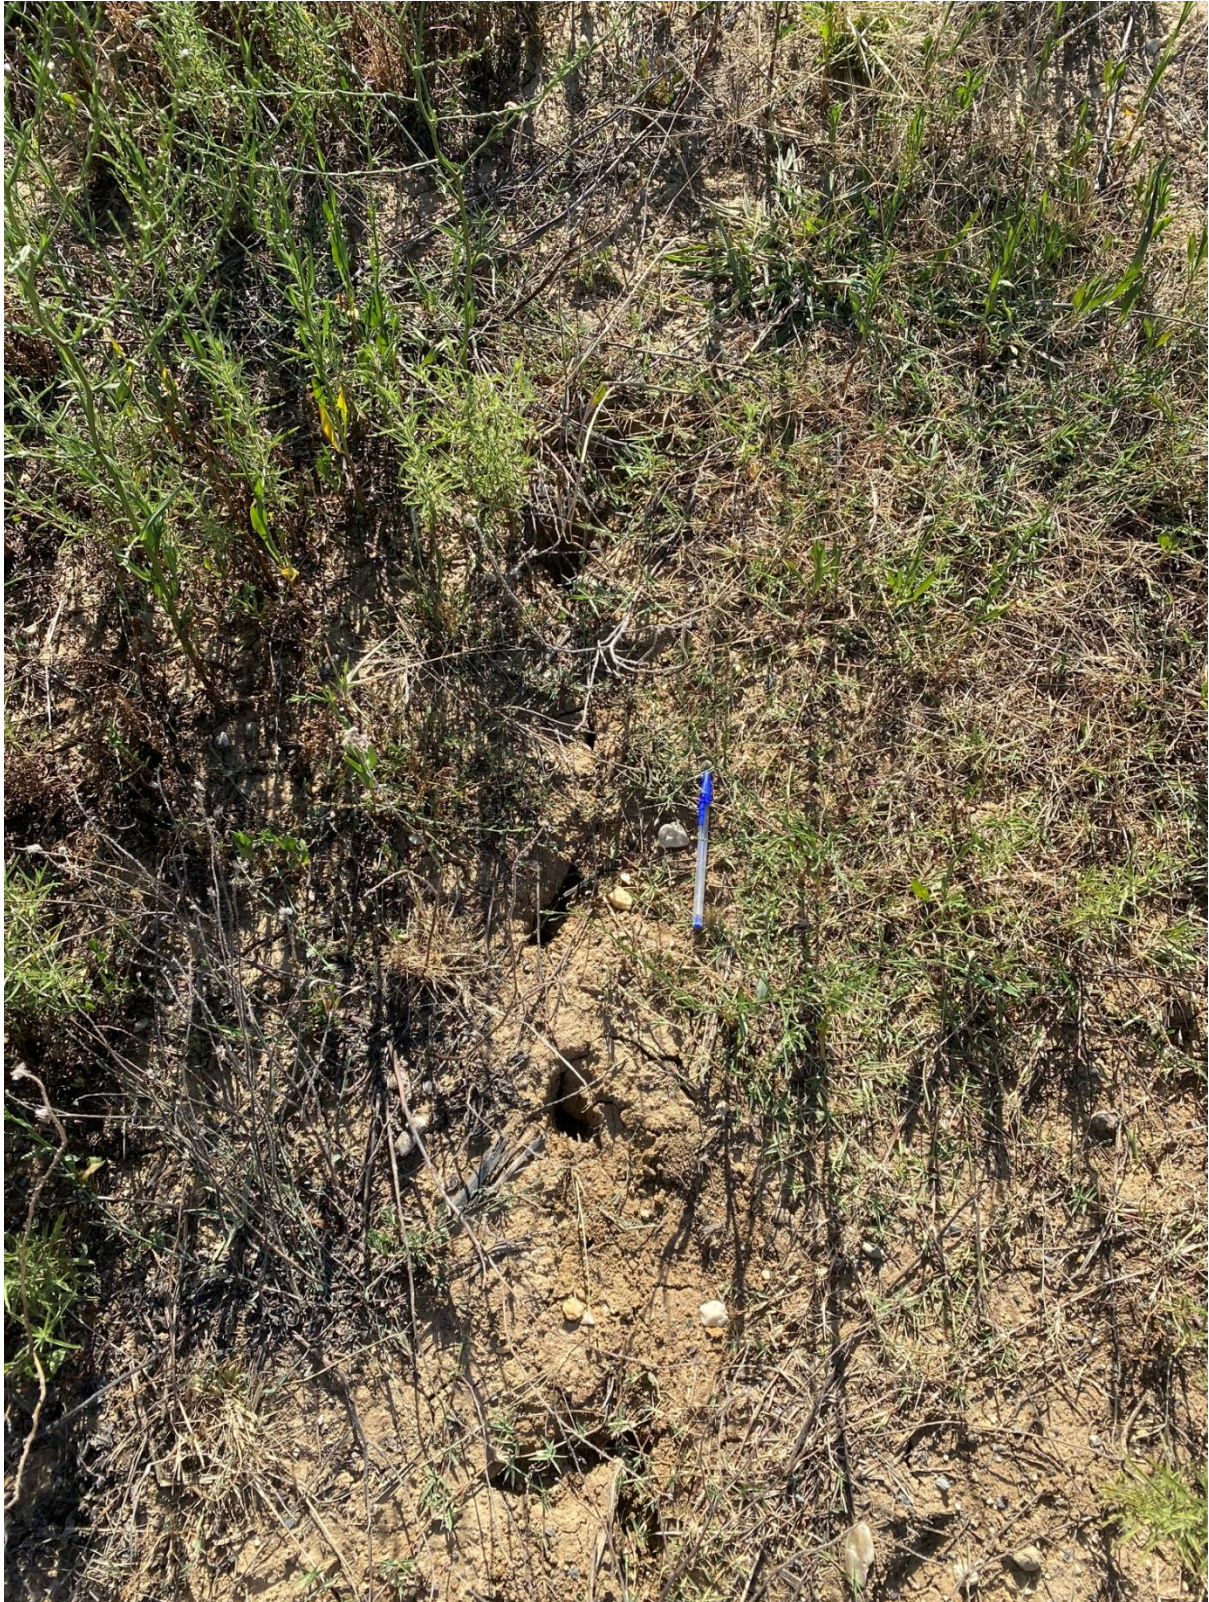
Photograph 5: The general surface and vegetation on site. Note surface desiccation cracking with pen for scale.

*Assumes bored piers and fissured soils; values are for compression, a reduction factor of 0.5 is recommended for tension. The top 1m shall be ignored. Surface desiccation cracking evident during site visit.

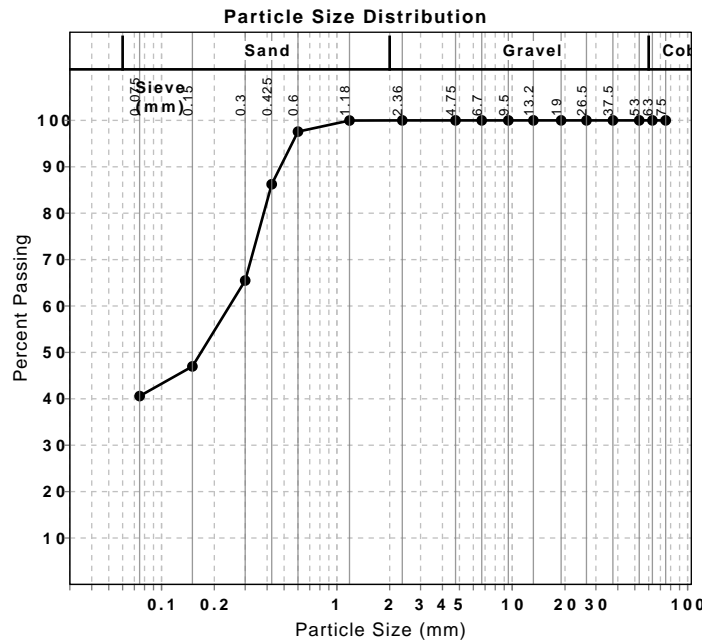
Atterberg Limit (AS1289 3.1.2 & 3.2.1 & 3.3.1)		Min	Max
Sample History	Air Dried		
Preparation Method	Dry Sieve		
Liquid Limit (%)	32		
Plastic Limit (%)	12		
Plasticity Index (%)	20
