Proposed Wodonga Creek Activation Project & Walking Trail, Gateway Island Wodonga, VIC 3690

Cultural Heritage Management Plan No: 20361

Version 2

Date: 21/9/25

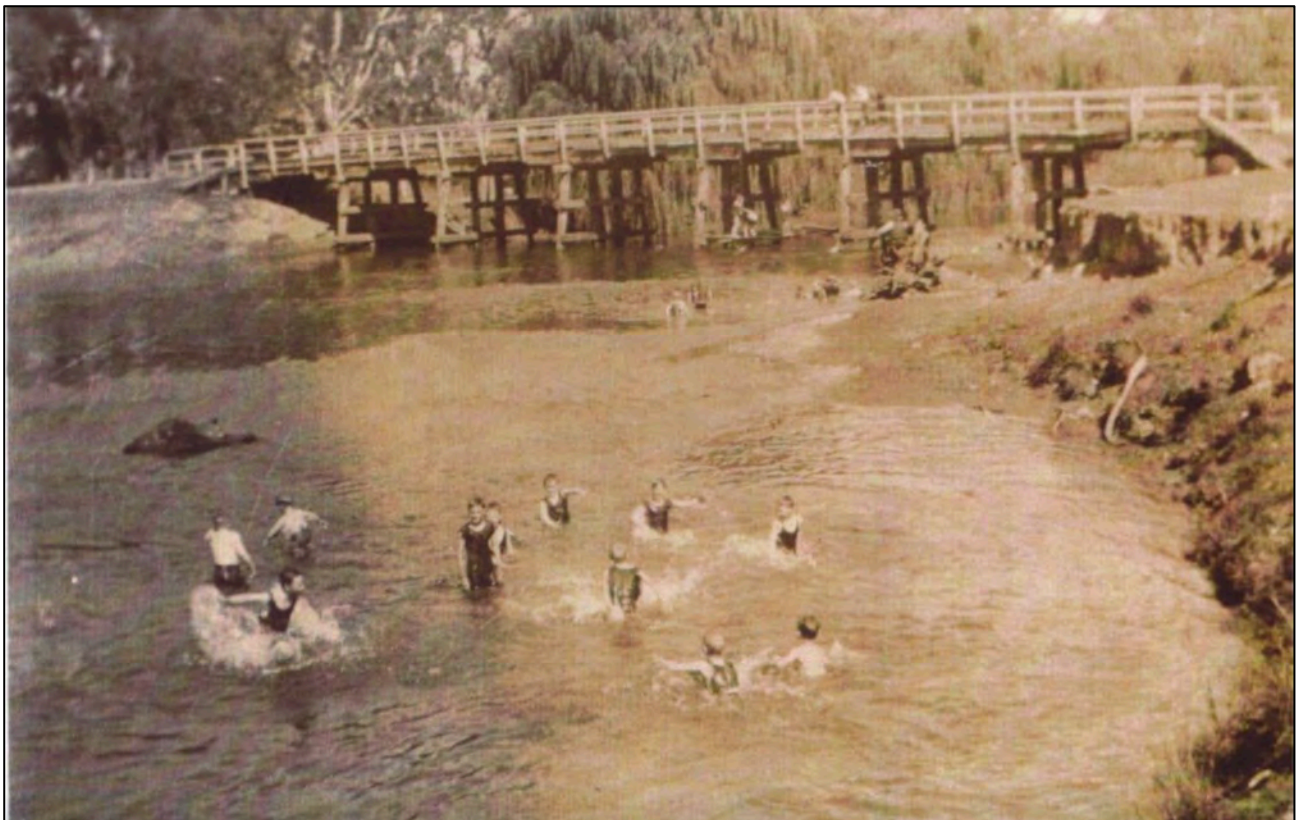
Image 1: The Wodonga 'Swimming Pool' near the Wodonga Creek Stock Bridge, c.1950s, illustrating denuded and eroding Creek banks, as well as willow trees growing within the Activity Area.

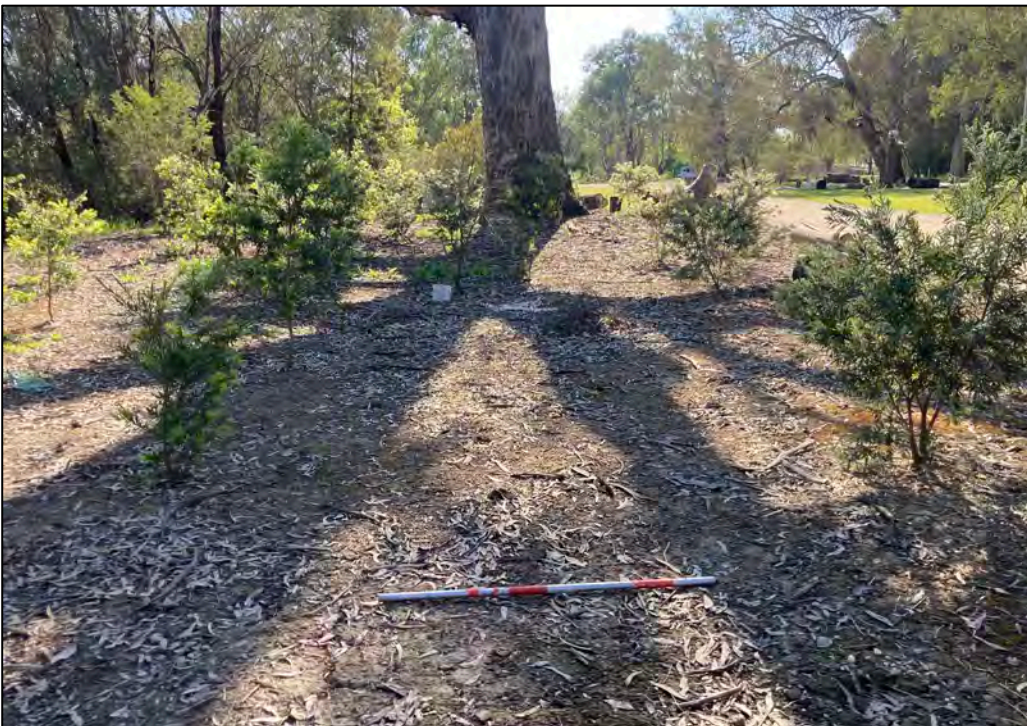
Photo 1: Revegetated & landscaped areas on the south bank, west end of alignment, east orientation. Good GSV, imported fill. Photo: D.Wall, 2024.

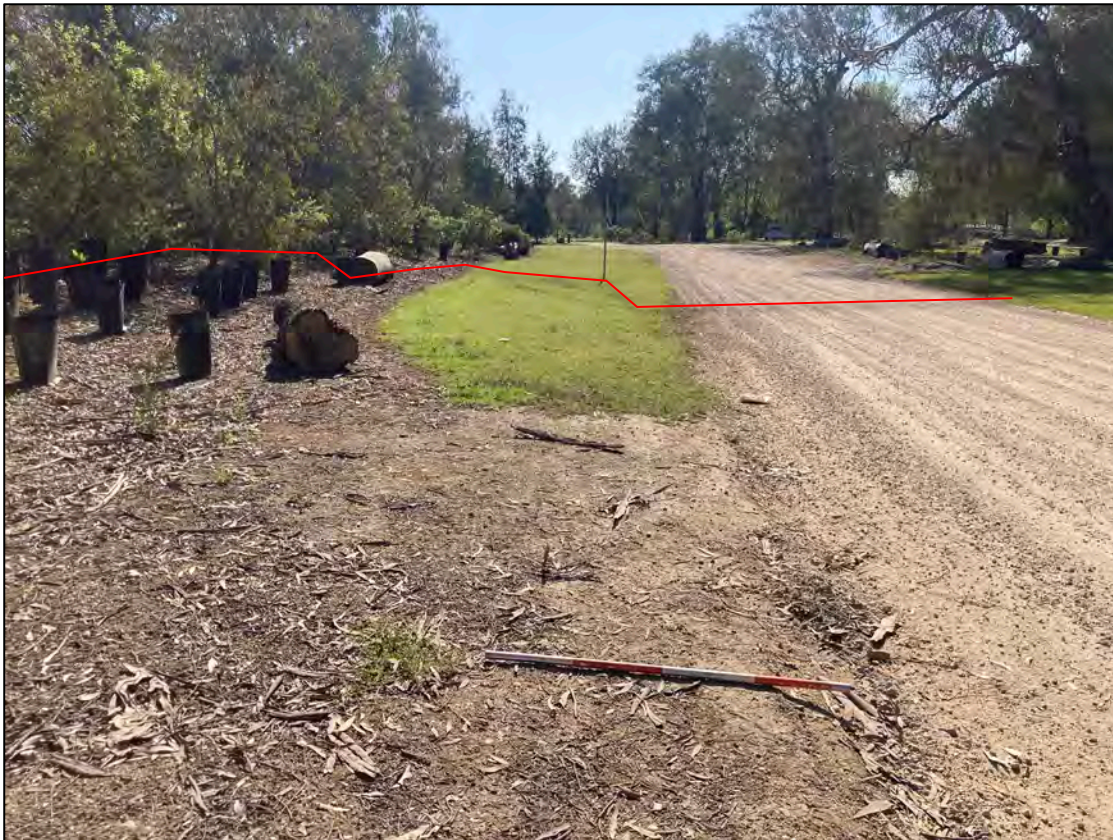
Photo 2: Revegetated & landscaped areas on the south bank, west end of alignment, north orientation. Good GSV, lack of natural surfaces. Photo: D.Wall, 2024.

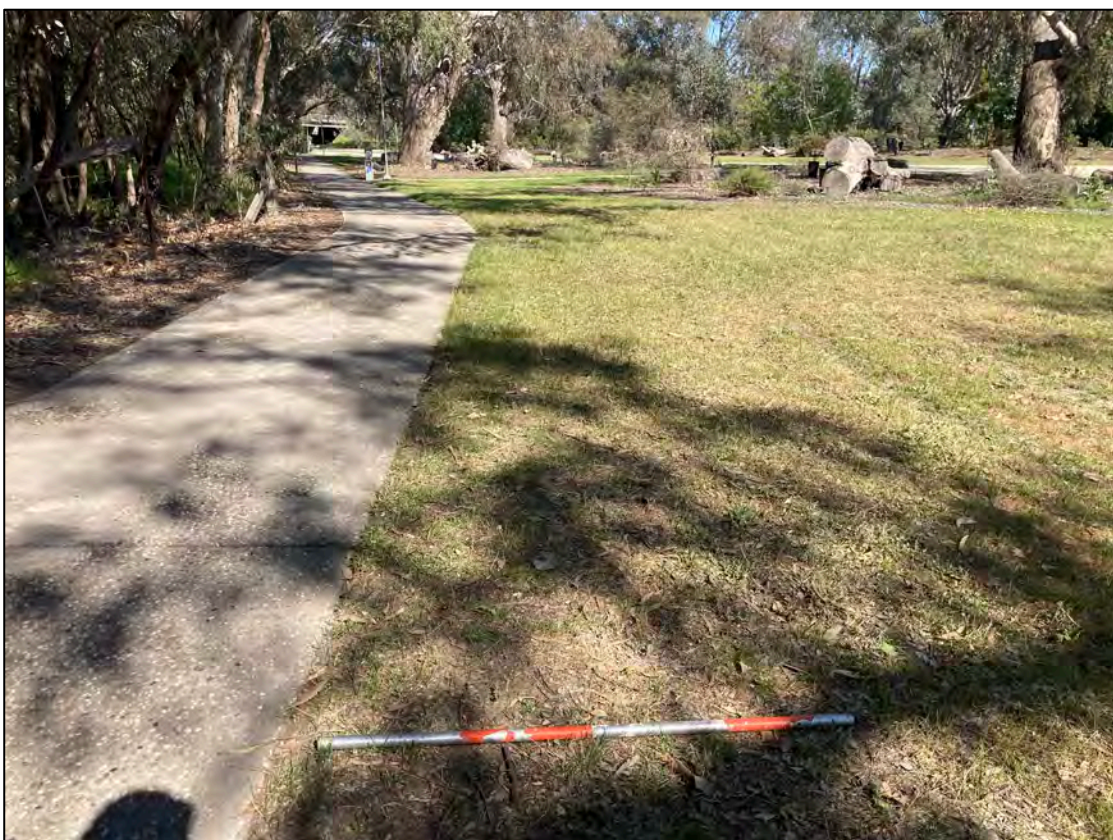
Photo 3: Existing path and landscaped area on the south bank, west end of alignment, west orientation. Good GSV, lack of natural surfaces. Photo: D.Wall, 2024.

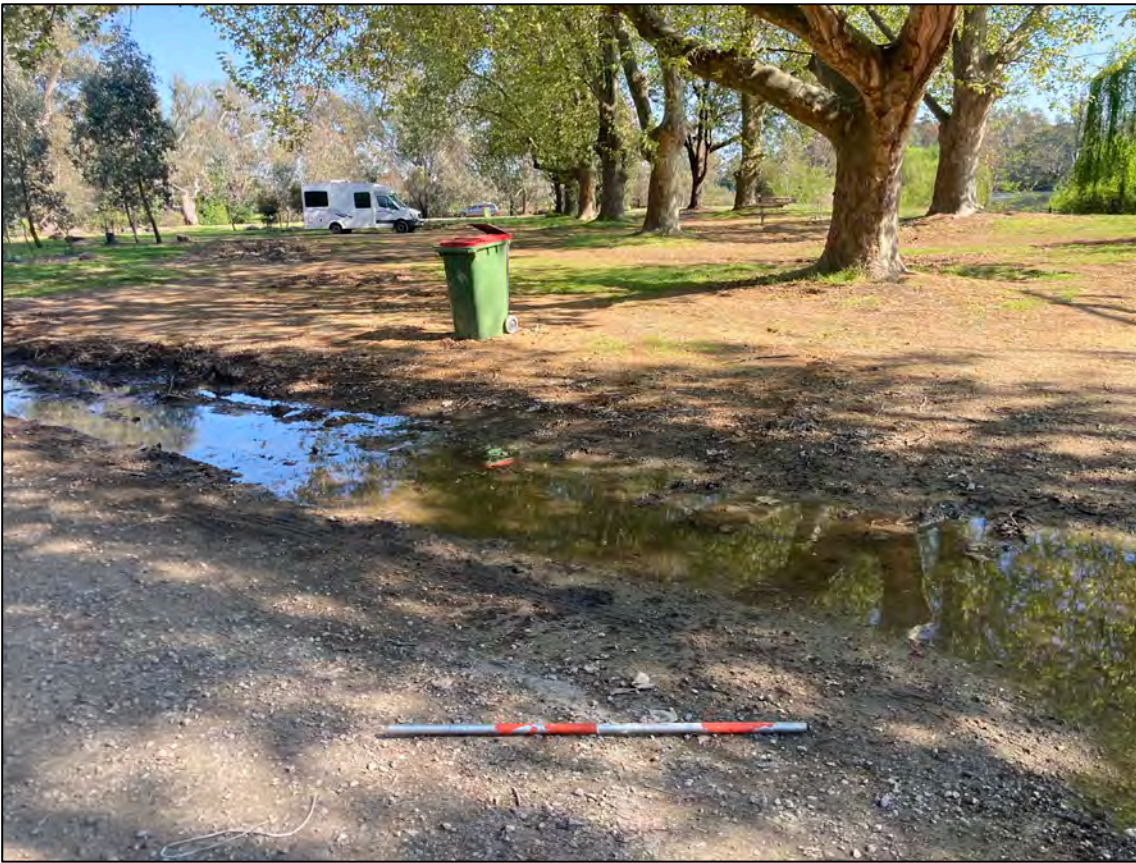
Photo 4: South bank, excellent GSV, imported surfaces and high disturbance. Photo: D.Wall, 2024.

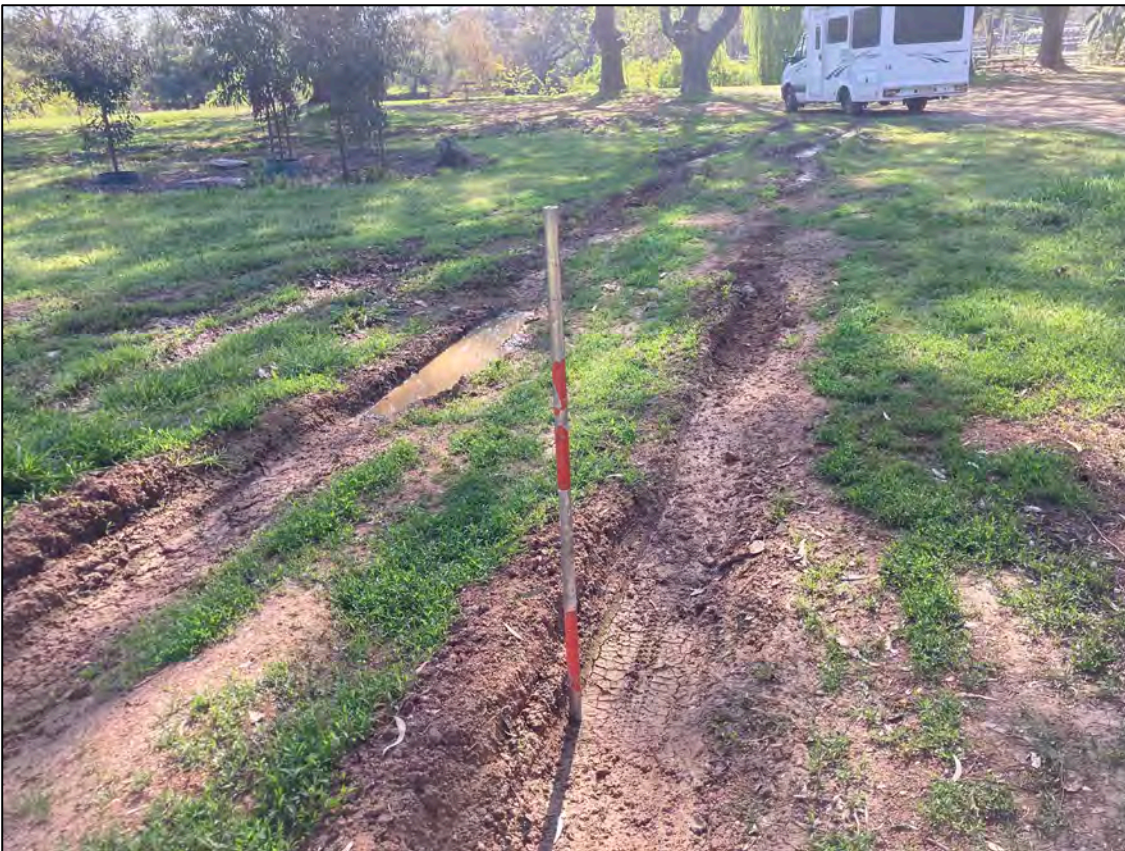
Photo 5: South bank, excellent GSV, high disturbance on heavy clay soils. Photo: D.Wall, 2024.

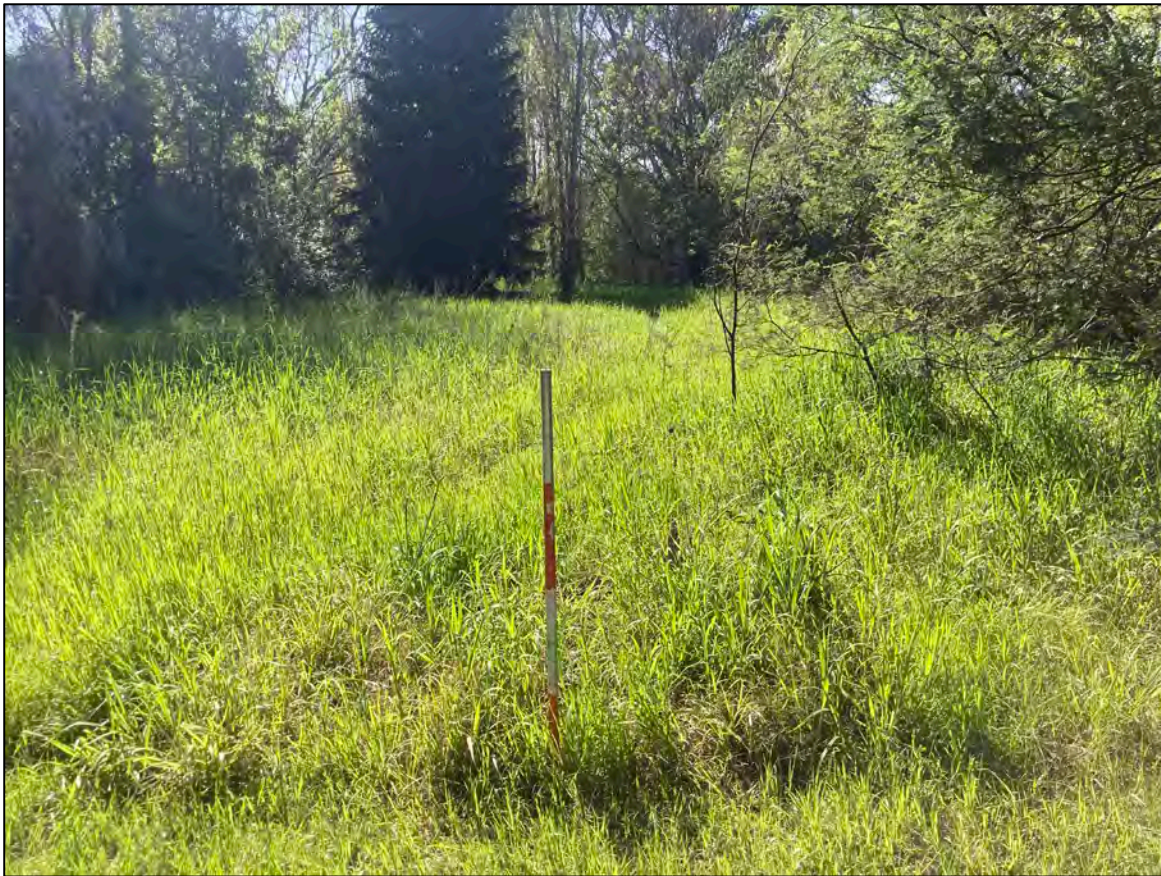
Photo 6: Thick grass cover, north bank on private land, east orientation. Poor GSV. Photo: D.Wall, 2024.

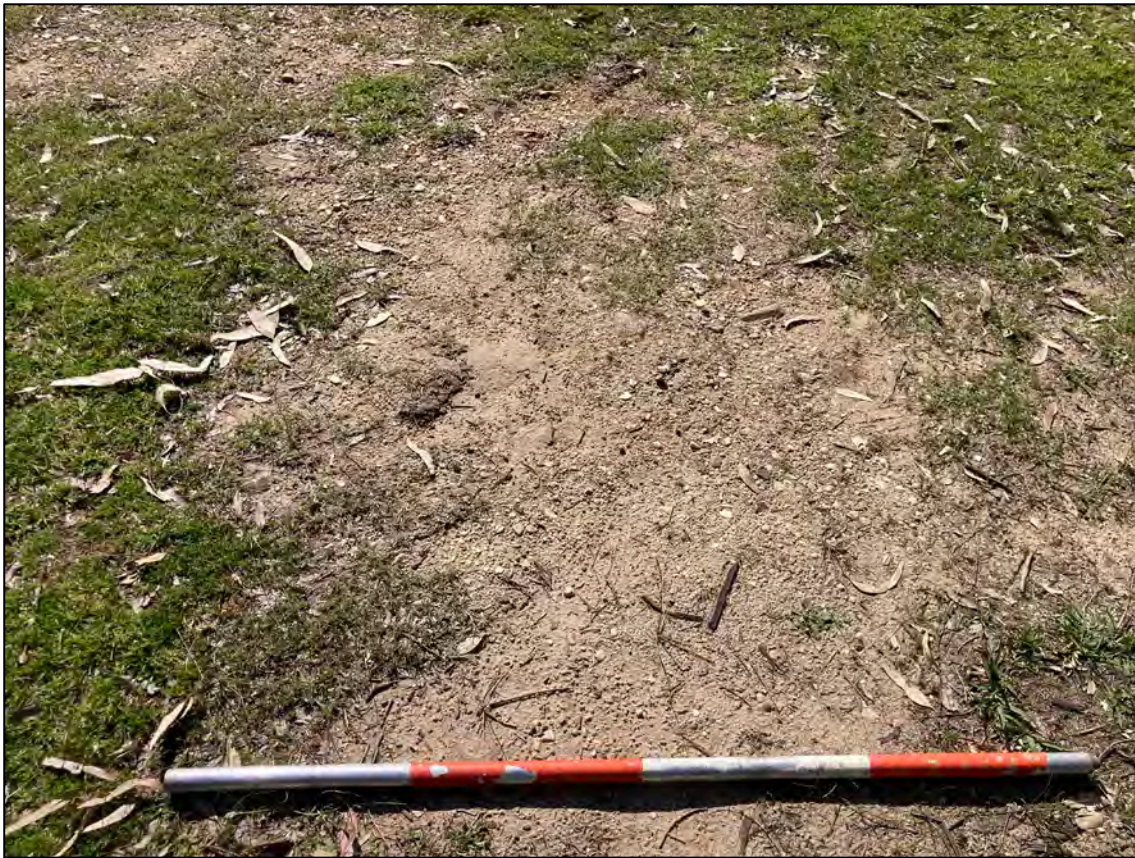
Photo 8: Areas of exposure showing a mixed soil profile of imported fill on the proposed track alignment. Photo: D.Wall, 2024.

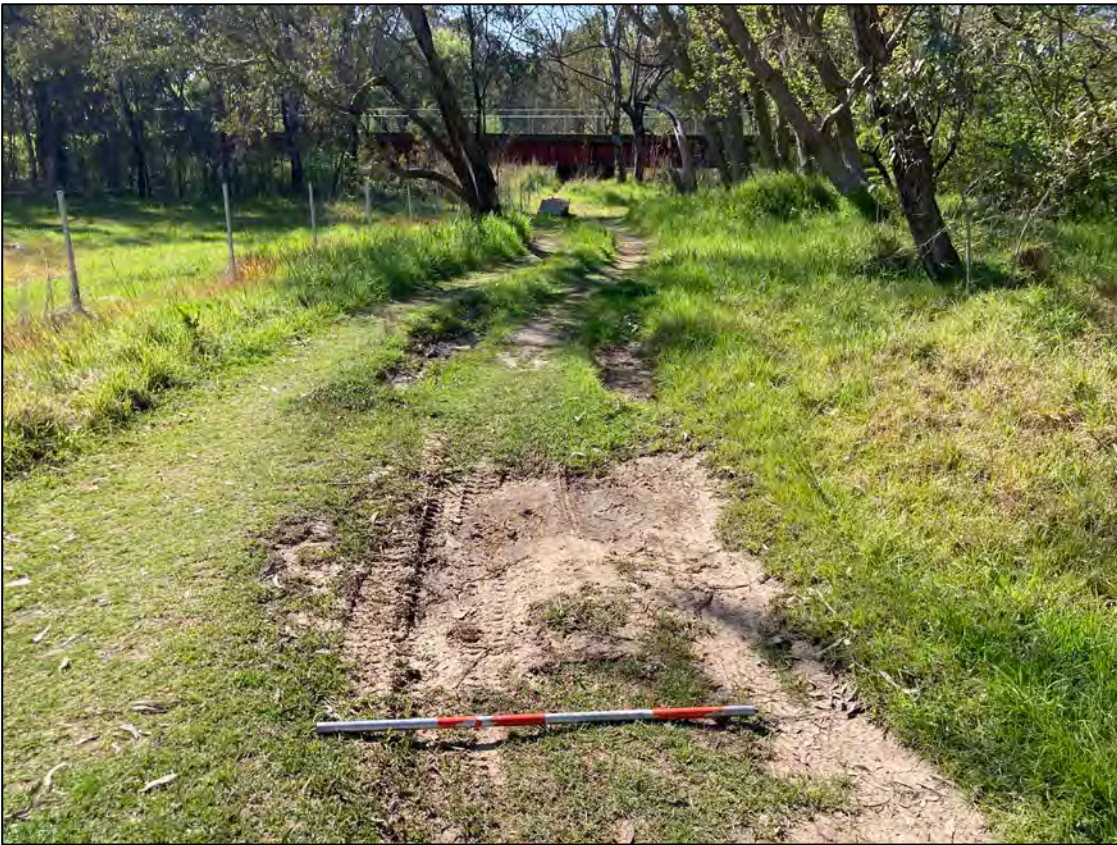
Photo 10: Existing vehicle track disturbance on an informal track. East end of alignment, East orientation, Good GSV. Photo: D.Wall, 2024.

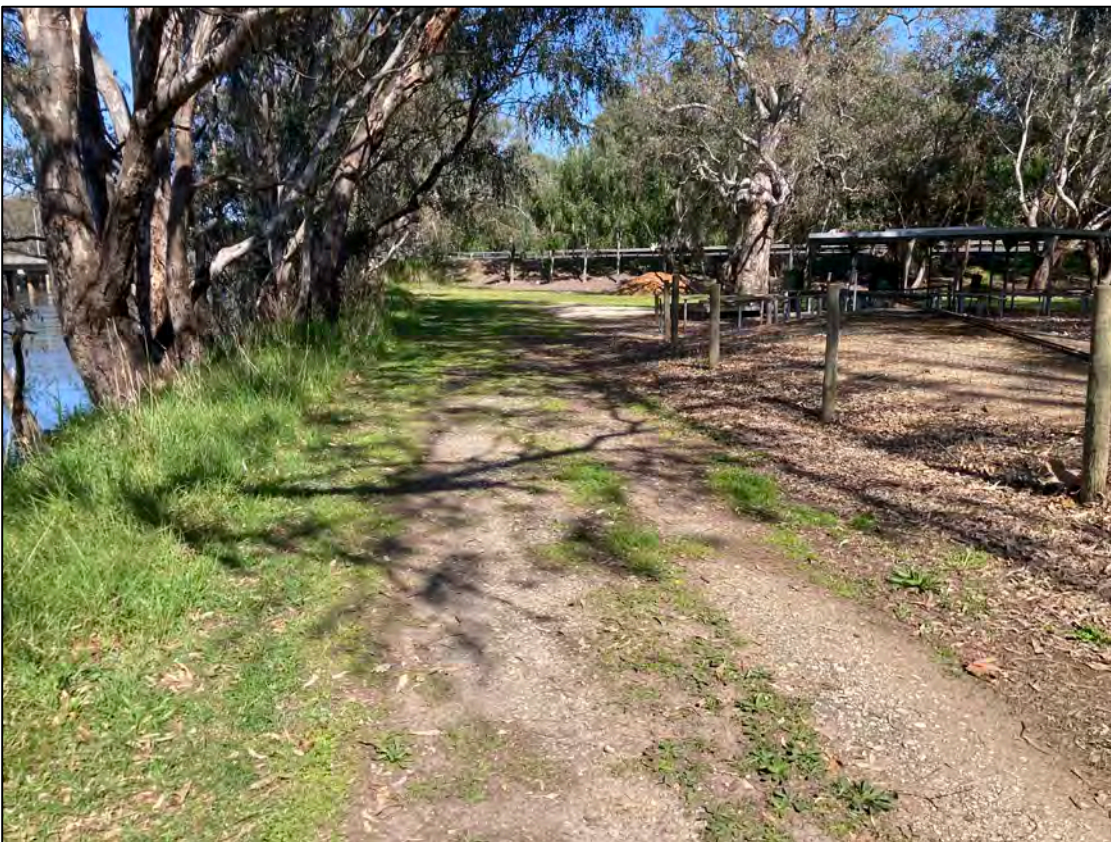
Photo 2: Existing track on alignment, Diamond Park. Fair GSV, west orientation. Photo: D.Wall, 2024.

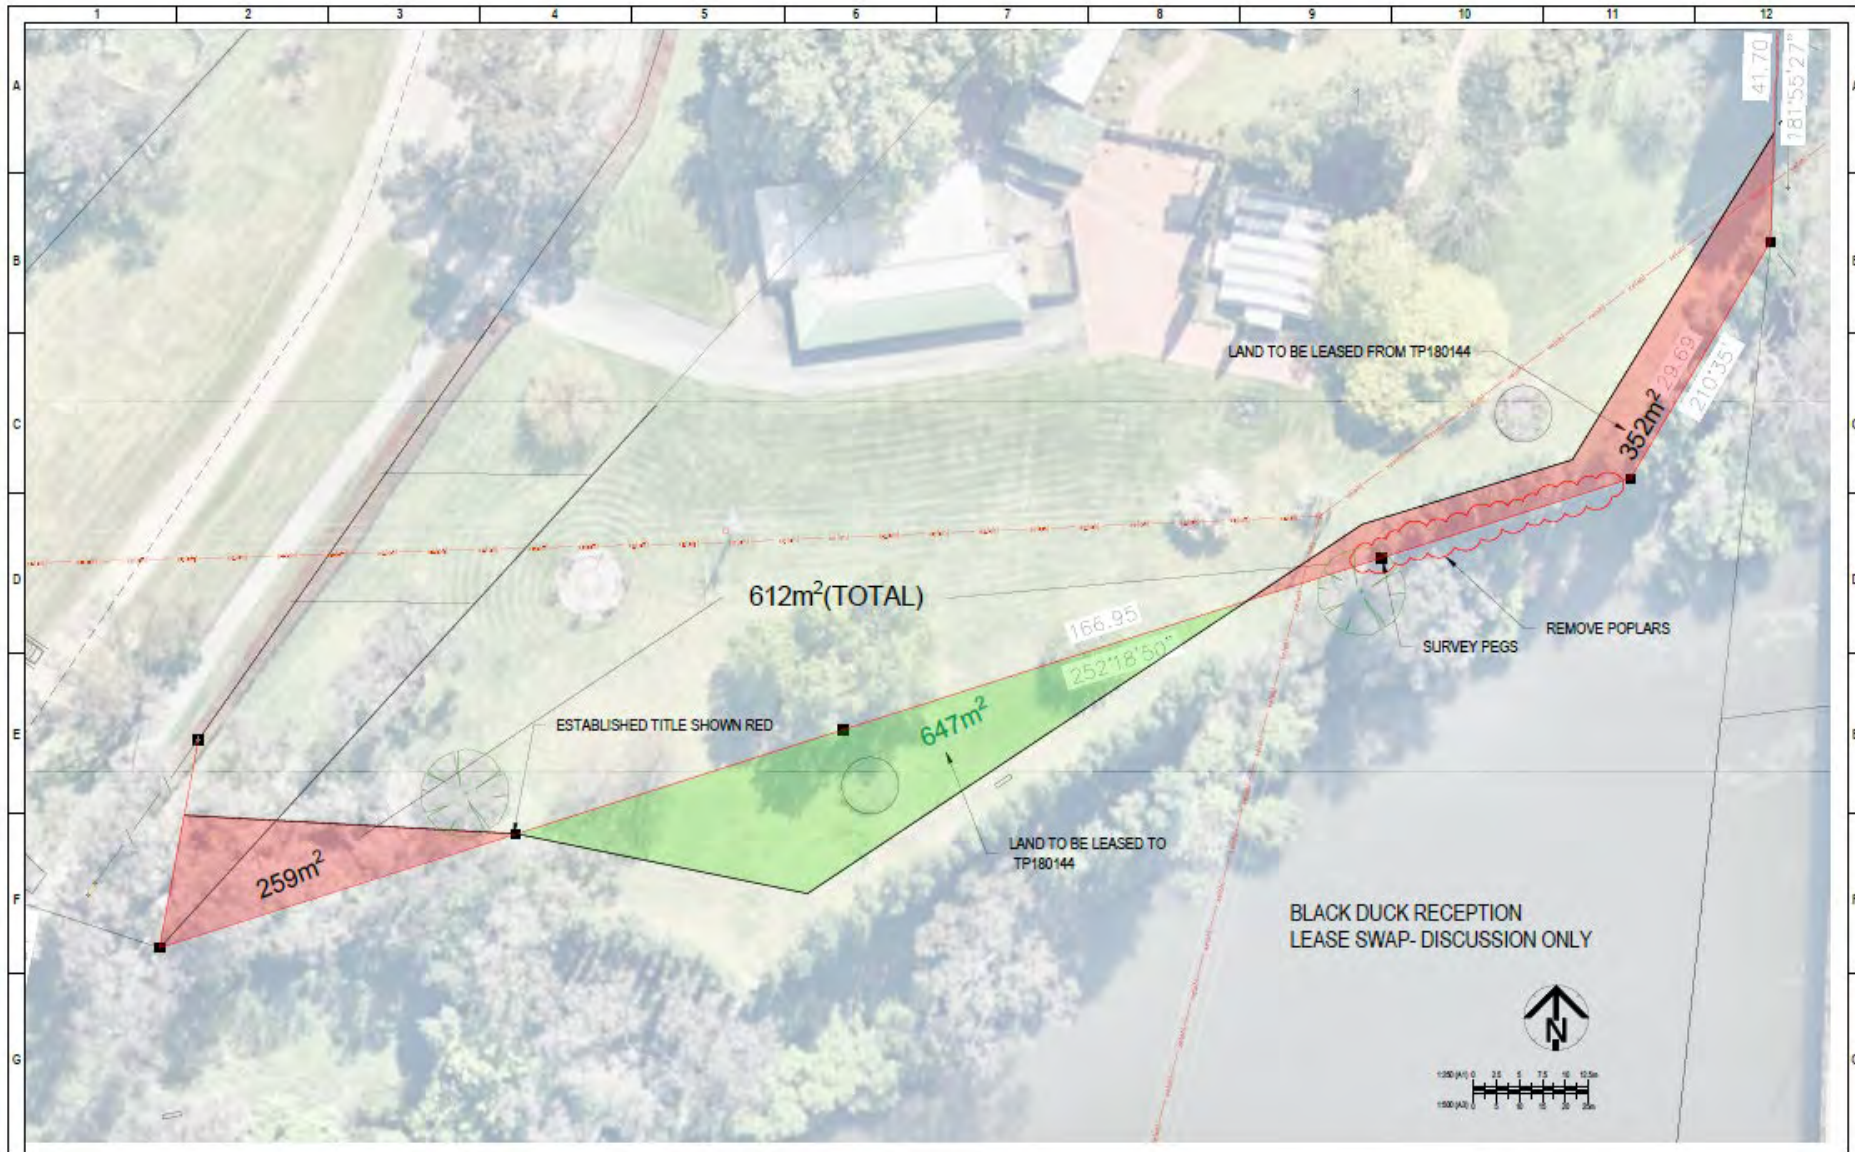
Appendix 7: Area of land to be leased by Wodonga City Council from Gypsy Gardens
