## **GEOTECHNICAL INVESTIGATION FOR KYABRAM FAUNA PARK**

Zoos Victoria  
Elliott Avenue, PARKVILLE 3052

V430  
23 April 2025

**RE: GEOTECHNICAL INVESTIGATION for KYABRAM FAUNA PARK**

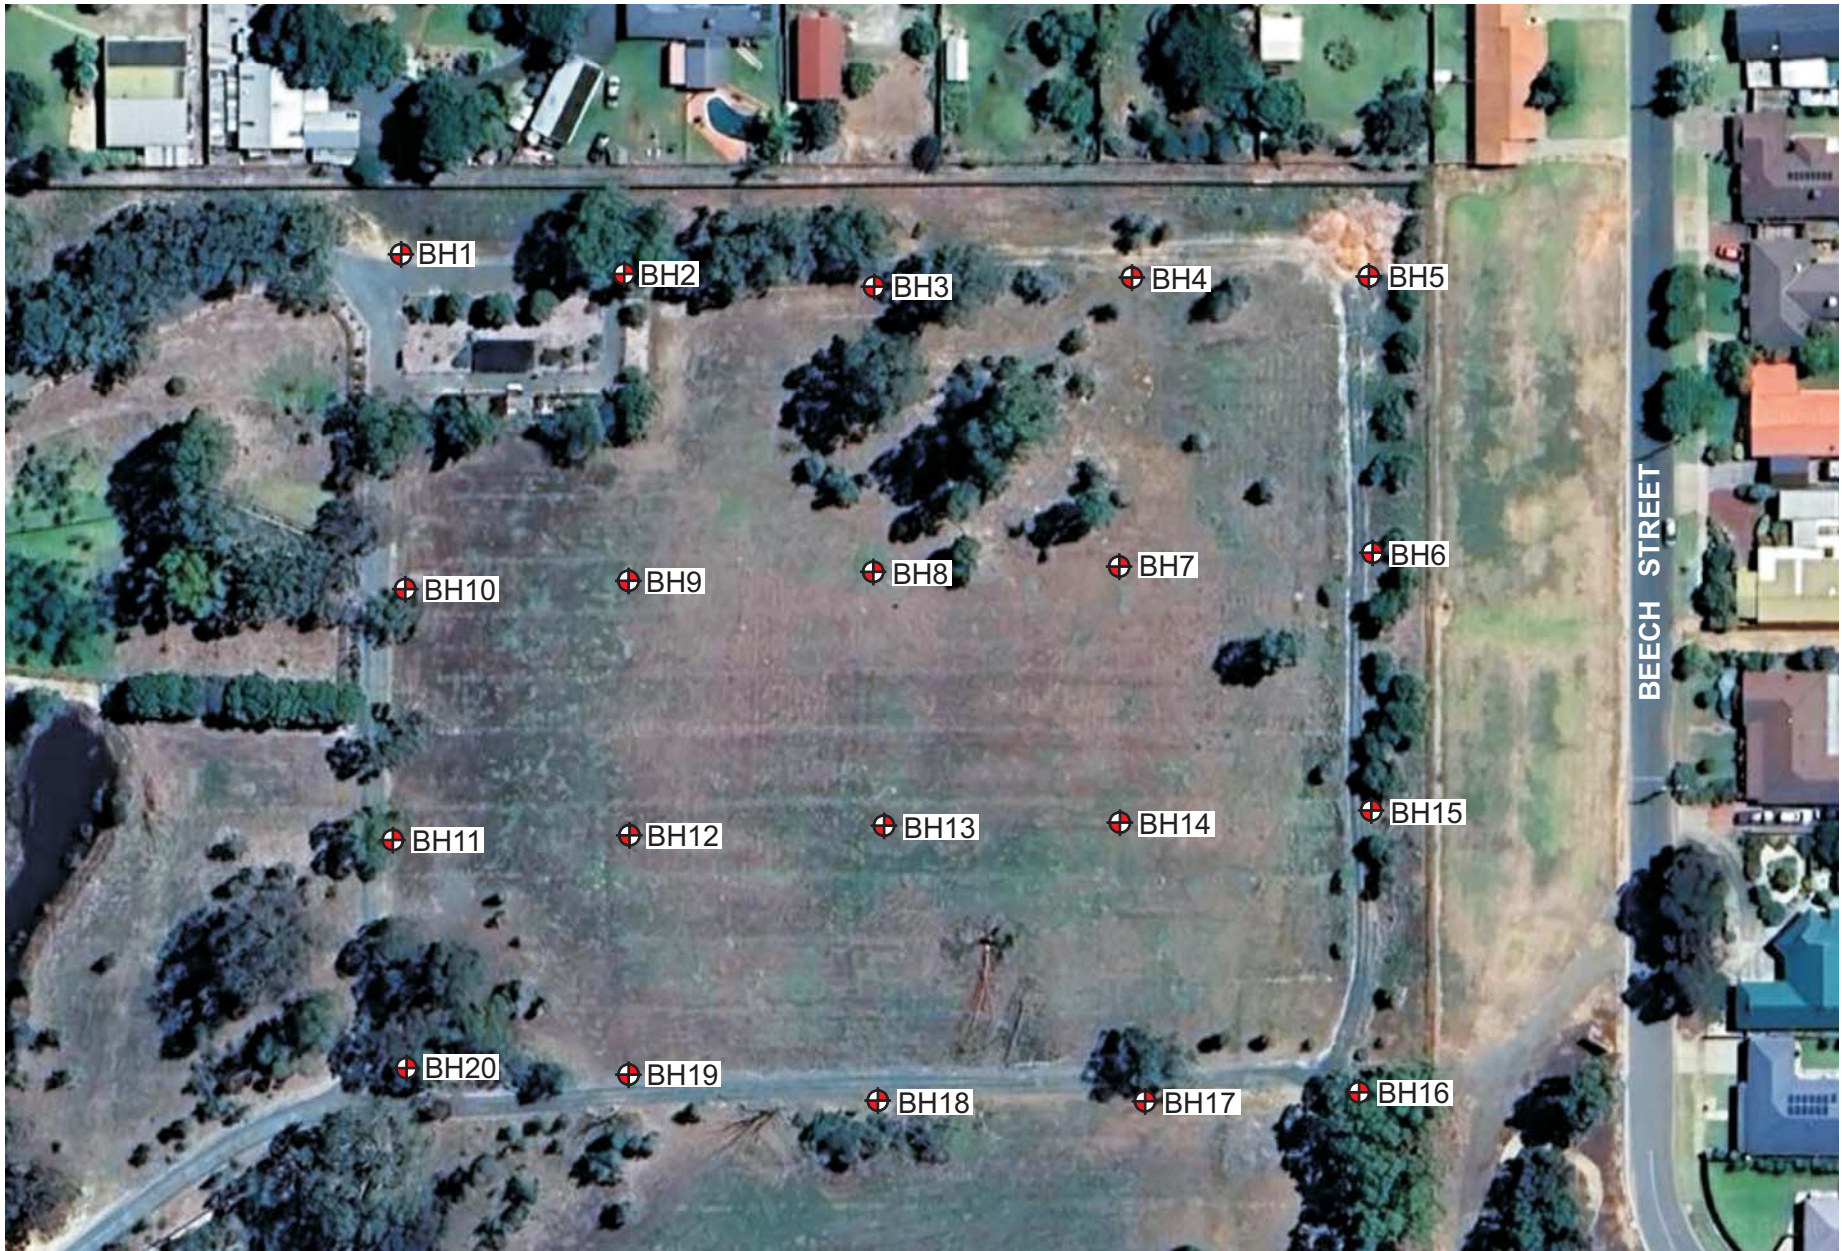
| VICGEO | | JOB NO | SCALE | FIG. 1 |

The approximate locations of the boreholes are shown on Figure 1 whilst the engineering borehole logs are included in Appendix 1.

Figure 1: Site Plan
